“The Strengthening of Damodar Bridge on the
Bengal-Nagpur Railway.”

By DOUGLAS HENRY REMFRY, Assoc. M. Inst. C.E.

THE STRENGTHENING OF DAMODAR BRIDGE.

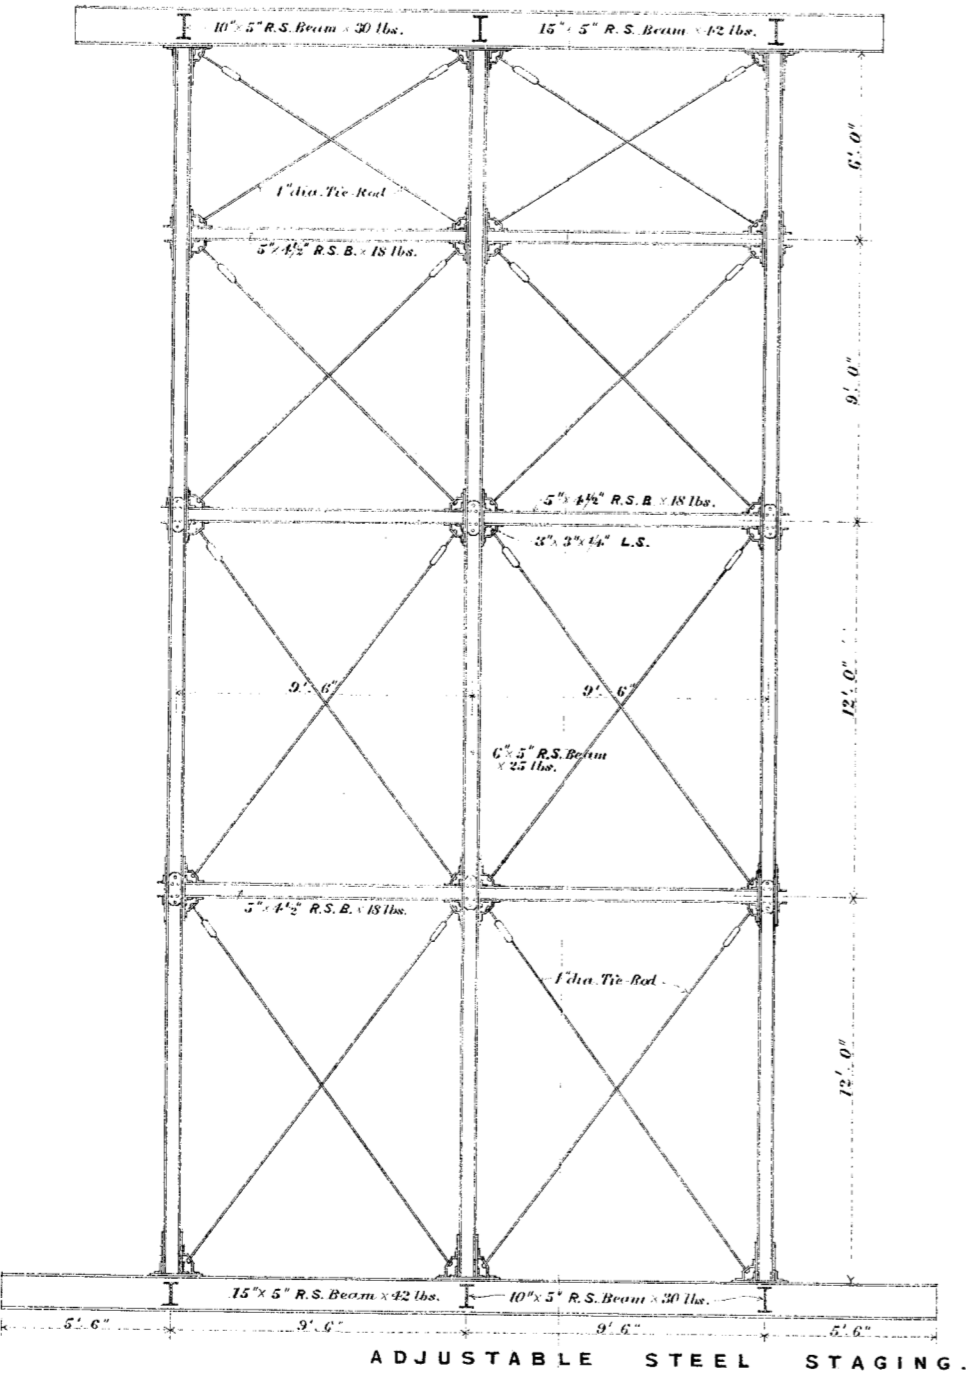
Fig 1.

To support the girders, adjustable steel stagings were used, three stagings to each span (Figs. 1, Plate 6). Each staging consisted of six rolled-steel columns 6 inches by 5 inches by 25 lbs., strongly braced together, and having heavy girders at the top and bottom to distribute the load. The columns were in lengths of 12, 9, and 6 feet, and the height of a staging could be varied at pleasure, in steps of 3 feet, from 8 feet 6 inches to 41 feet 6 inches, by using suitable combinations of these lengths. All parts were supposed to be interchangeable.

The stagings were erected on the sandy river-bed, and to prevent the current from underscouring them six small steel well-cylinders were sunk under each staging. These cylinders were 3 feet 6 inches in diameter, built up of $\frac{1}{4}$ -inch plate in stakes of about 4 feet, which could be bolted together. The length of the cylinders varied between

11 feet and 15 feet according to the exposure of the situation. Where heavy scour was anticipated the cylinders were pitched with sand-bags and stone. On completing the strengthening of a span, the adjustable stagings were hauled off to the next span, and the well-cylinders withdrawn and used again. For sinking the latter, small Bull dredgers were used.

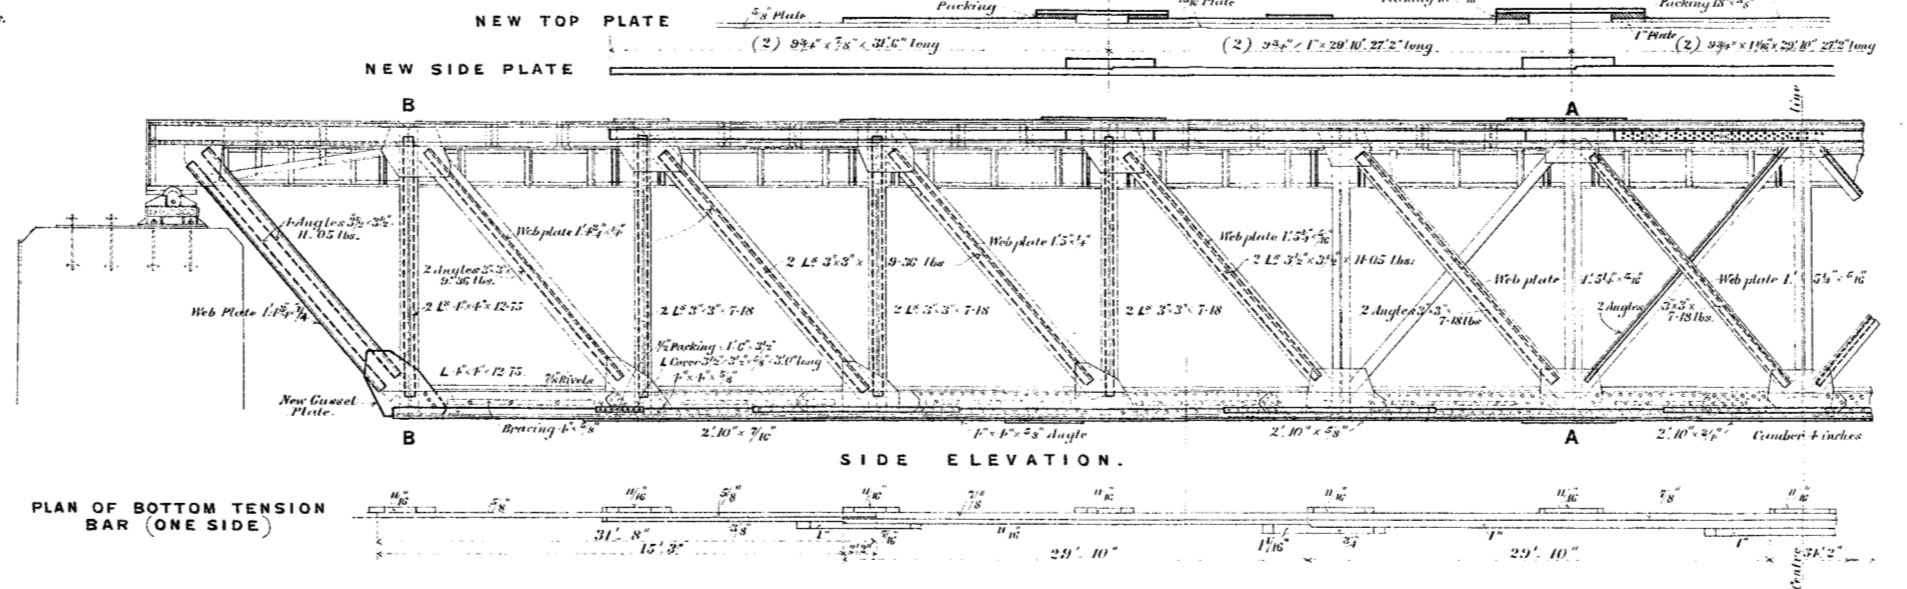
Fig 2.

Details of the Strengthening.—The top booms were strengthened by the addition of new top and side plates (Figs. 2, Plate 6). In the central bays a top plate 18 inches by $\frac{5}{8}$ inch was used, with two side plates $9\frac{3}{4}$ inches by $1\frac{1}{8}$ inch, the total additional sectional area being about 32 square inches. The new top plates gave very little trouble even under traffic, but the side plates needed careful manipulation, as in order to fix them into position a very large number of the most important rivets in the span, connecting the top gusset-plates to the top booms, had to be cut out. Under traffic conditions this could only be done by rimering the holes and using turned bolts. The bottom booms were strengthened by having heavy angle-irons riveted along their lower edges, and a new flange-plate added (Figs. 2, Plate 6). The central bays in this case were strengthened by the addition of two angles 4 inches by 4 inches by $\frac{5}{8}$ inch, and a flange-plate 2 feet 10 inches by $\frac{3}{4}$ inch, a total net section of over 31 square inches. None of the drilling for these bottom-boom plates could be done in position, as there was not sufficient clearance for the pneumatic drills to work. Very careful measurement and marking off for each span was therefore necessary.

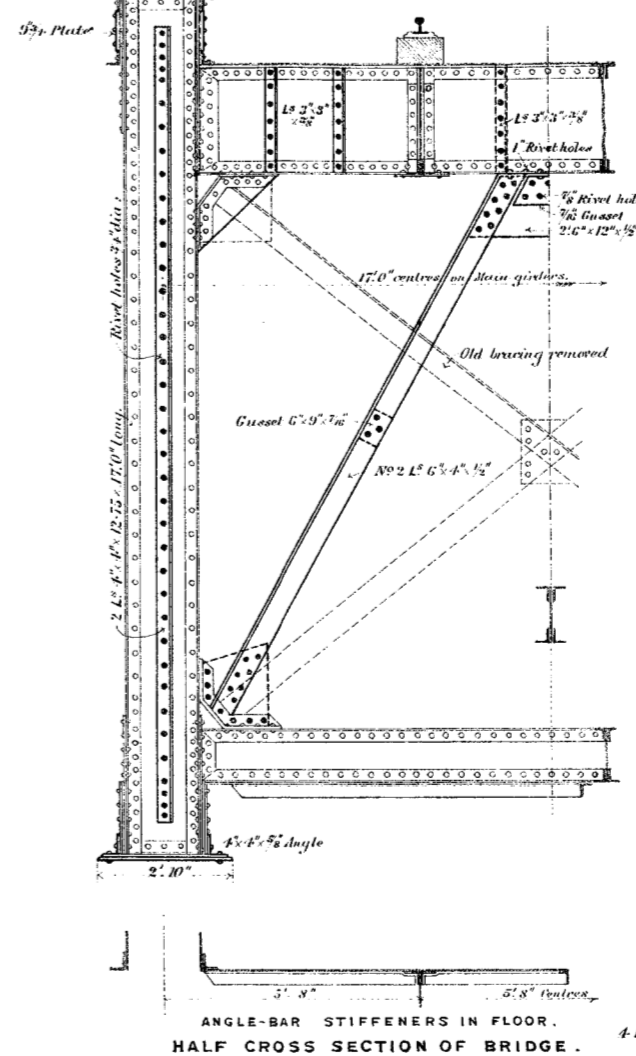
Fig 3.

The cross girders were strengthened by the addition of raking struts from the bottoms of the vertical posts which supported the cross girders at their centre (Fig. 3). The struts each consisted

of two angles, 6 inches by 4 inches by $\frac{1}{2}$ inch, riveted back to back. The rail-bearers required a little stiffening to their webs. It was also found necessary to replace eight of the main gusset-plates on each span, as they were deficient in sectional area and could not contain sufficient rivets. To do this under traffic it was necessary to block the line for at least five hours, as the plates were large and heavy and had to be carried a considerable distance to the shops for new plates to be drilled from them. About 40,000 holes had to be drilled per span. Pneumatic drills were used and most of the drilling was done in place. It was very difficult to get enough rivets into some of the joints, especially into the ends of the central diagonals. Experiments were made with a special type of chrome vanadium steel rivet for places where the rivet area was too small. These had a shearing strength about 45 per cent. greater than an ordinary mild steel rivet, and tests seemed to indicate also that a greater bearing resistance could be relied upon in the plates, when these special rivets were used, than with mild steel rivets. The deflection of the girders after strengthening was reduced under live loads by 26 to 30 per cent. In most of the spans practically no permanent set was observable on the first passage of a train after strengthening. The camber was on the average unaltered.
